## **RIPARIAN RECOVERY NETWORK NEWS**

**No. 13, June 6, 2019**

### **May 2019 Flooding and Its Impact**

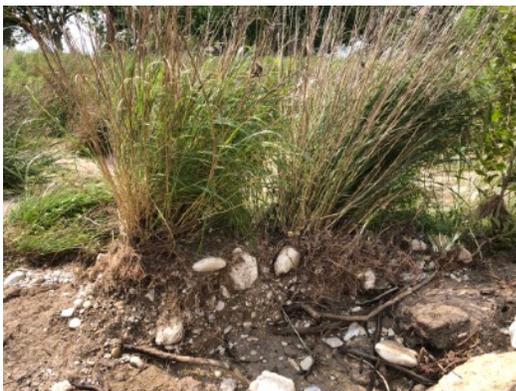
What happened at Jackaroo Ranch during that one week period is instructive as to how even minor floods can alter the landscape. Ryan McGillicuddy from Texas Parks and Wildlife reported that the most damage was to the upstream berm that shapes the bioswale created to slow surface runoff and protect the Blanco from pollutants. This was likely due to its location on the property - the berm sits on the downstream side of the low water crossing at Little Arkansas. He suspects the eddying force of water pouring over the crossing is what eroded the berm. But fortunately, as the picture on the left illustrates, the switchgrass planted there performed its stabilizing function preventing further erosion.

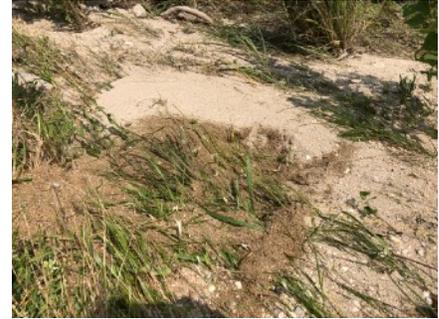
Ryan and Jackaroo's land manager were both pleased with how, overall, the site handled both events. Despite local scouring, there were lots of places where the native vegetation captured sediments. At first glance, the area pictured at the top of the next page appears to

have been scoured. But Ryan dug down 4-6 inches and found White-top sedge and other vegetation. This particular area lost up to 3 feet of soil in the 2015 flood. The covered plants will grow up through the soil that was deposited on top of them - thus illustrating the importance of riparian vegetation in rebuilding banks after catastrophic flood events.

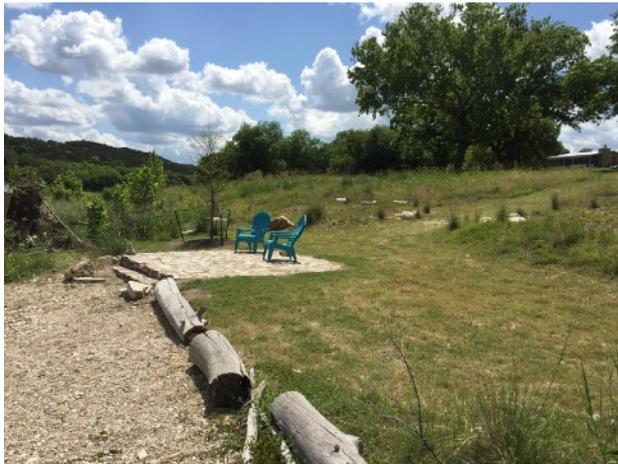
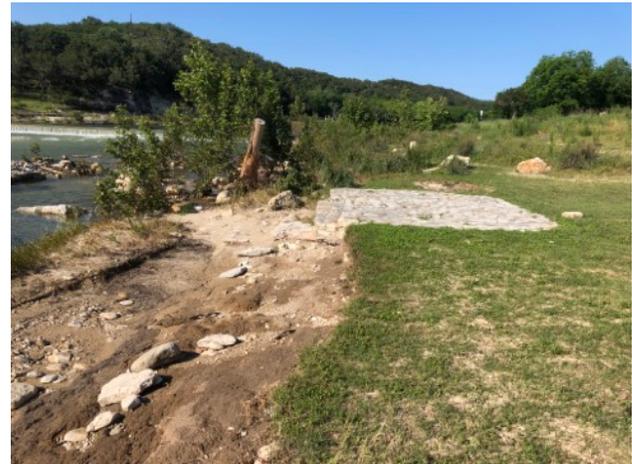
The other damage was to the river access area shown in the before and after pictures below. In the before picture on the left you'll notice a Bald Cypress planted on the far side of the patio. In the after picture you can see that the small tree was swept away by the floodwaters. This containerized tree was planted just a few years ago and did not have sufficient time to extend its roots both laterally and vertically. Thus, it was more vulnerable than trees of similar size growing up naturally. The bare area between the mown area and the river was scoured, but the vegetated portion held up remarkably well. Note that the gravel removed by this most recent flood was actually deposited there by the 2015 flood. Consideration is now being given to extending the vegetated area down to the water's edge using the same combination of Nimblewill and Thunder Turf as was used on the upper portion.

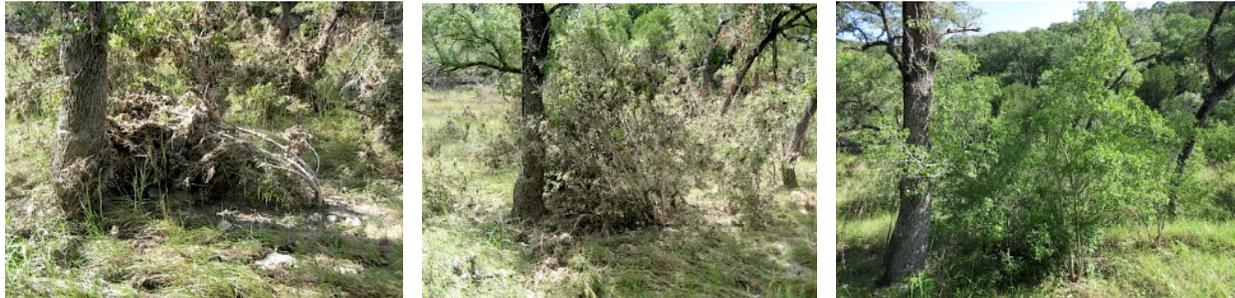
trees that inhabit his riparian zone. River walnuts are brittle and more would be lost if it weren't for the readiness with which they shed their leaves to protect their trunks. But that's not a problem as within a few weeks lost leaves are quickly replaced. By contrast, Persimmons hang on to their leaves and compensate by being very flexible. So their trunks rarely break, but right after the flood they "looked like a Christmas tree in a sock" as illustrated in the left hand photograph below. The leaves coupled with dense branching collect smaller flood debris that often includes small fish, rocks, onion plants, etc. and the multiple trunks become braided in response to the swirling waters.

The prostate Persimmons would eventually straighten up on their own as the flood debris dried up and was removed by the wind, birds and other critters. That's undoubtedly what happened before he moved to that stretch of creek in 2004. But our hard working Master Naturalist and his wife chose to accelerate the process by removing the debris and gently persuading the trees to stand more upright. He observes the tree will tell you when it is time to stop - when you start feeling too much resistance. The pair actually waits a few weeks after flooding to begin the unwrapping process because dried debris is easier to removed and often can be dislodged by simply shaking the tree. And don't worry about losing some leaves or removing all of the debris. Mother Nature will take care of the rest before the next spring comes around. The middle picture above shows the same Persimmon after the debris has been removed and the one on the right is the same tree today.
